RE: Drinking Water Sampling – Post Remediation Sampling
Northside Elementary, Northside Early Childhood, Northside Middle
Project Number: 924222

Drinking Water Assessment
 North Side Community Schools Early Childhood Center
 North Side Community Schools

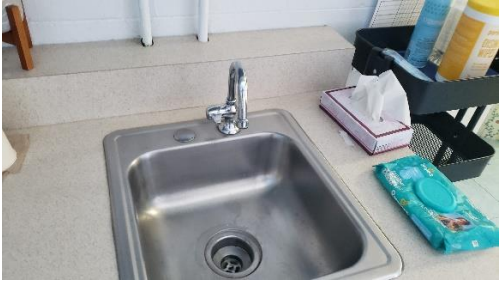
ID:	337-NSEC-03	Location:	Classroom 101		
Photo:

Manufacturer:	Central		
		Description:			
		Classroom Sink, Right			
		Result:	<1.0	ppb	
Recommended Action:		Date Sampled:	11/1/2024	By:	MM

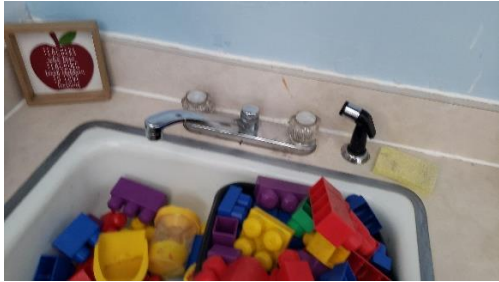
ID:	337-NSEC-08	Location:	Classroom 102		
Photo:

Manufacturer:	Delta		
		Description:			
		Classroom Sink			
		Result:	<1.0	ppb	
Recommended Action:		Date Sampled:	11/1/2024	By:	MM

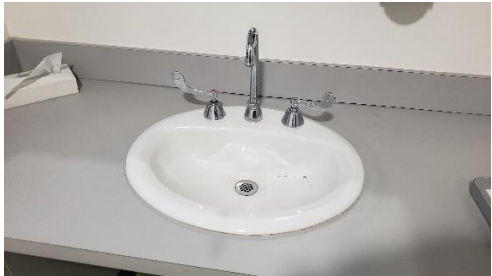
ID:	337-NSE-01	Location:	(6) Floor 2 Restroom	
Photo:

Manufacturer:	Unknown	
		Description:		
		Restroom Sink		
		Result:	<1.0	ppb
Recommended Action:		Date Sampled:	11/1/2024	By: MM

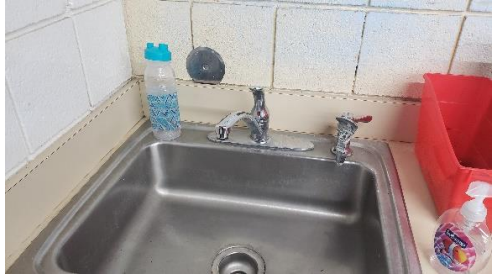
ID:	337-NSE-11	Location:	(1) Classroom 104	
Photo:

Manufacturer:	Unknown	
		Description:		
		Classroom Sink		
		Result:	<1.0	ppb
Recommended Action:		Date Sampled:	11/1/2024	By: MM

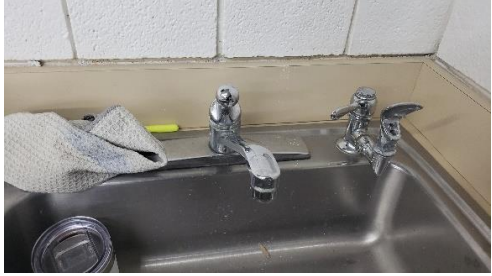
ID:	337-NSE-13	Location:	(1) Classroom 105	
Photo:

Manufacturer:	Delta	
		Description:		
		Classroom Sink		
		Result:	<1.0	ppb
Recommended Action:		Date Sampled:	11/1/2024	By: MM

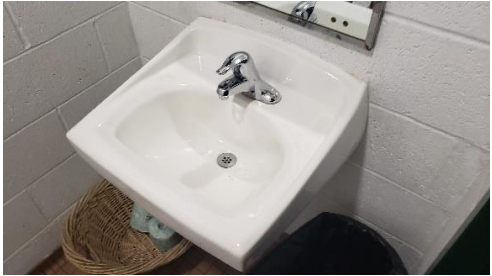
ID:	337-NSE-04	Location:	(1) Main Hall Front RR	
-----	------------	-----------	------------------------	--

Manufacturer:	Moen	
		Description:		
		Restroom Sink		
		Result:	<1.0	ppb
		Date Sampled:	11/1/2024	By: MM
Recommended Action:

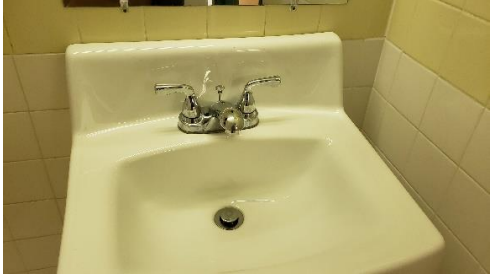
ID:	337-NSE-68	Location:	(7) Classroom 703	
Photo:

Manufacturer:	Moen	
		Description:		
		Restroom Sink, Right		
		Result:	<1.0	ppb
Date Sampled:		11/1/2024	By:	MM
Recommended Action:

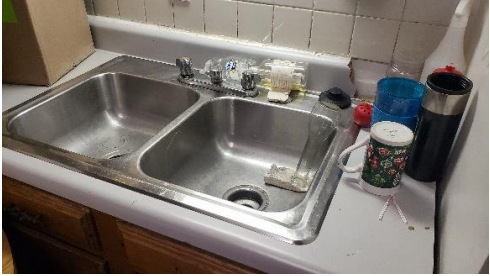
ID:	337-NSE-76	Location:	(7) Break Room	
Photo:

Manufacturer:	Delta	
		Description:		
		Kitchenette Sink		
		Result:	<1.0	ppb
Date Sampled:		11/1/2024	By:	MM
Recommended Action:

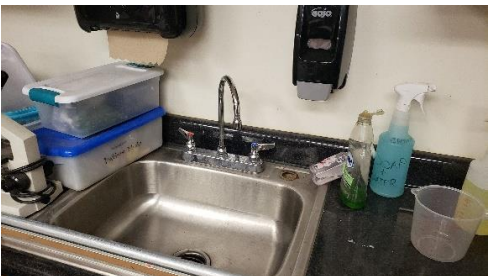
ID:	337-NSE-81	Location:	(3) Basement	
Photo:

Manufacturer:	T&S Brass	
		Description:		
		Classroom Sink		
		Result:	<1.0	ppb
Date Sampled:		11/1/2024	By:	MM
Recommended Action:

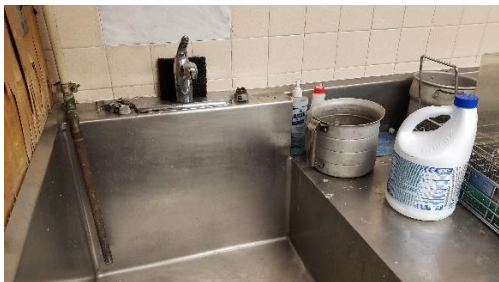
ID:	337-NSM-11	Location:	Kitchen	
Photo:

Manufacturer:	Unknown	
		Description:		
		Prep Sink, South Wall		
		Result:	4.2	ppb
Recommended Action:		Date Sampled:	11/1/2024	By: MM

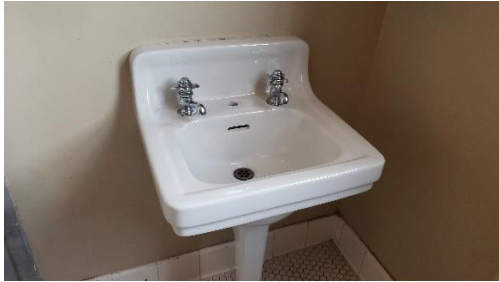
ID:	337-NSM-29	Location:	Floor 3 Men's RR	
Photo:

Manufacturer:	Central	
		Description:		
		Restroom Sink (Composite of 2)		
		Result:	<1.0	ppb
Recommended Action:		Date Sampled:	11/1/2024	By: MM

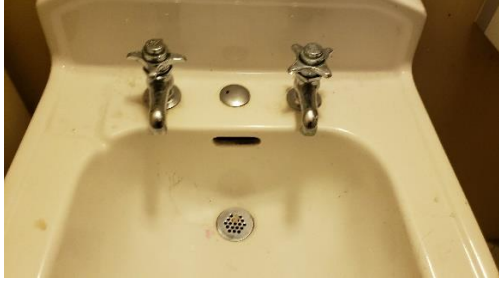
ID:	337-NSM-35	Location:	Floor 3.5 Women's RR	
Photo:

Manufacturer:	Central	
		Description:		
		Restroom Sink (Composite of 2)		
		Result:	<1.0	ppb
Recommended Action:		Date Sampled:	11/1/2024	By: MM

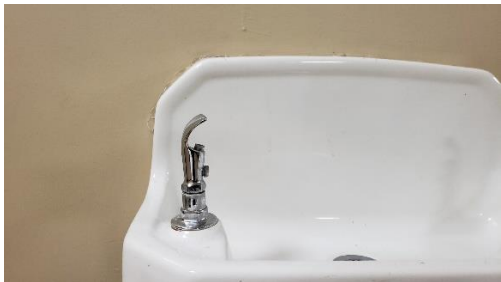
ID:	337-NSM-36	Location:	Floor 3.5 Hallway	
Photo:

Manufacturer:	Central	
		Description:		
		Drinking Fountain Bubbler, Left		
		Result:	22.3	ppb
		Date Sampled:	11/1/2024	By: MM
Recommended Action:	Remove from Service

In accordance with the requirements set forth in Missouri Bill 681/662, fixtures exhibiting lead concentrations above 5 ppb must be remediated by replacement of lead-containing pipes, solder, fittings or fixtures with lead-free components, or the school shall install filtration at each point where water enters the building until such time as the source can be remediated. If installing a filter is not feasible, the school shall provide purified water at each outlet inventoried.

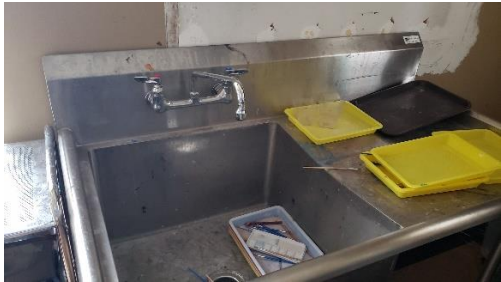
ID:	337-NSM-39	Location:	Floor 3.5 Art Room	
Photo:

Manufacturer:	T&S Brass	
		Description:		
		Art Room Sink		
		Result:	1.4	ppb
		Date Sampled:	11/1/2024	By: MM
Recommended Action:
